HOOSIC RIVER WATERSHED ASSOCIATION

# Shoreline Survey Report & Action Plan: Summer 2012

Report Compiled by Julieanne Fontana

# I. Introduction: Hoosic River Shoreline Surveys

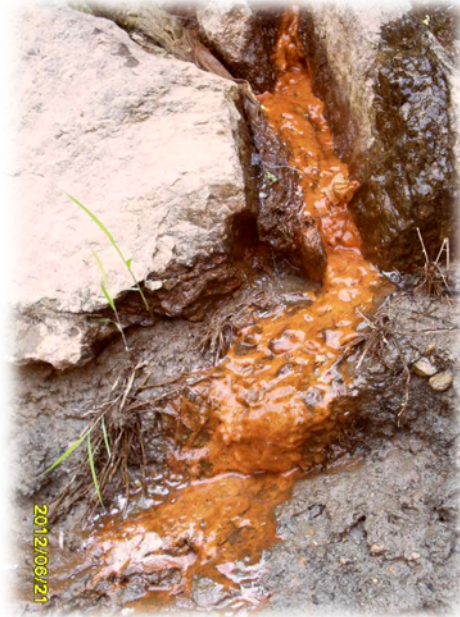
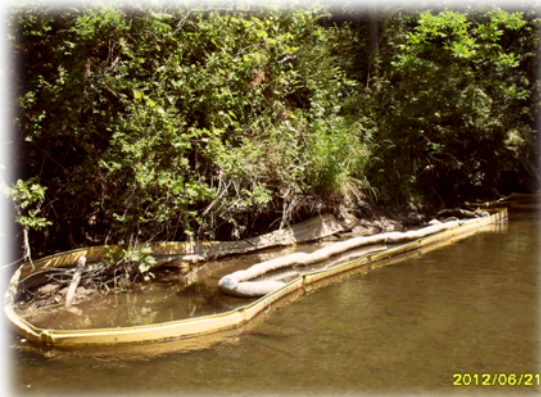
### **Priority Action 1: Oily, red-brown seepage**

GPS Location: N42.71785 W73.18877

Oily orange-brown seepage was seeping out of the ground near outflow pipes just upstream of Cole Avenue bridge in Williamstown. The seepage did not seem directly related to the outflow pipes, but may be an affect of the nearby road or old mill building. {Checked with DEP – seepage is organic with iron oxide; Editor}

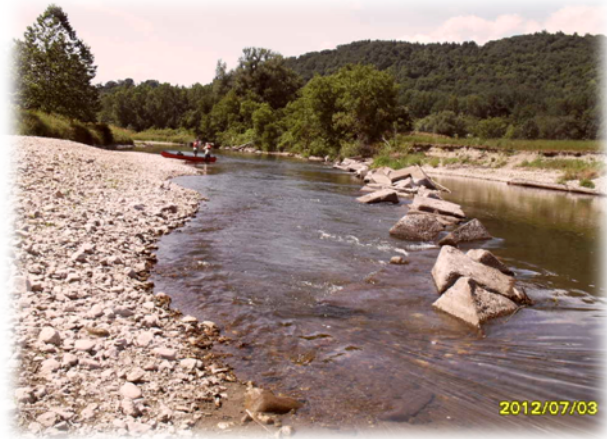
**Priority Action 3: Concrete blocks across stream width**

GPS Location: N42.82332 W73.30917

Between the Pownal Tannery Dam and Little Hoosic River Confluence, concrete blocks run diagonally down and across the stream. Only a small area of the stream flow is passible. The concrete blocks seem to have been riprap in the past, though have been across the stream since at least 2006 according the Google Earth past satellite images.

Natural Resource and Assets	Problems	Priority Actions
<ul style="list-style-type: none"><li>•</li></ul>	<ul style="list-style-type: none"><li>• Tree blocking river passage</li><li>• Bank erosion</li><li>• Previous wastewater treatment plant spill</li></ul>	<ul style="list-style-type: none"><li>• Concrete blocks (see Priority Action for Immediate Attention section)</li></ul>

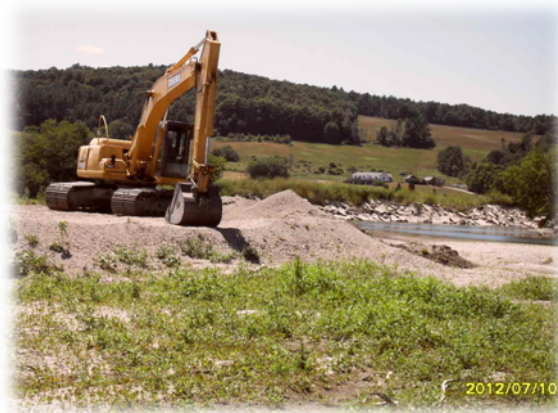
**Priority Action 4: Gravel backhoe**

GPS Location: N42.87394 W73.34931

A large excavator was observed not too far upstream from the Hoosick Falls stormwater chutes. There seemed to be a dirt road for the excavator to travel to the streambed, which was made up of gravel. It would be a good idea to check up on this operation and make sure the gravel mining is legal.

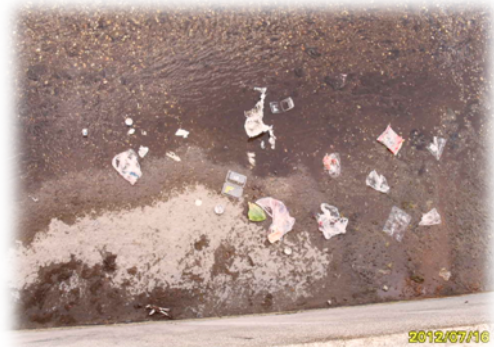
**Priority Action 5: Trash Dumping in Adams**

GPS Location: N42.61841 W73.12244

A small parking lot at the start of Noble Place was observed as a site of trash dumping into the chutes. Food containers were seen on the concrete below outside the main stream flow. Adding a city trash can to this site seems like a feasible solution to end dumping. {Signs and local fines could also help. Editor}

Natural Resource and Assets	Problems	Priority Actions
<ul style="list-style-type: none"><li>Stormwater chutes prevent flooding of downtown area.</li></ul>	<ul style="list-style-type: none"><li>Concrete chutes are a poor environment for wildlife</li></ul>	<ul style="list-style-type: none"><li>Trash dumping over side of chutes near Noble Bridge (see Priority Action for Immediate Attention section)</li></ul>

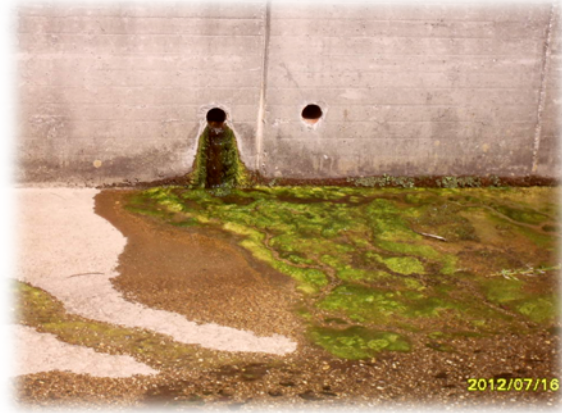
*Common outflow and algae along chutes*

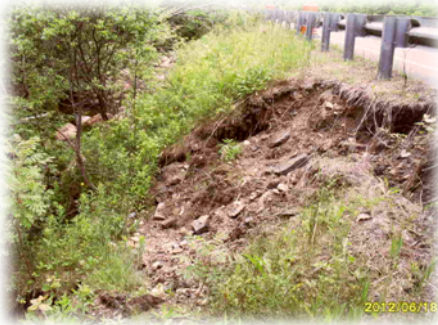
*Erosion along Route 8*

**Overview:** The North Branch of the Hoosic begins in Readsboro, Vermont, where it is shallow, steep, and hard to access. The river generally follows along Route 8, though most always has at least a small riparian area separating it from the road. The streambed is made of boulders and gravel and erosion exists in some areas close to the road. In one area in Stamford, the road is beginning to collapse and fall down the streambed.

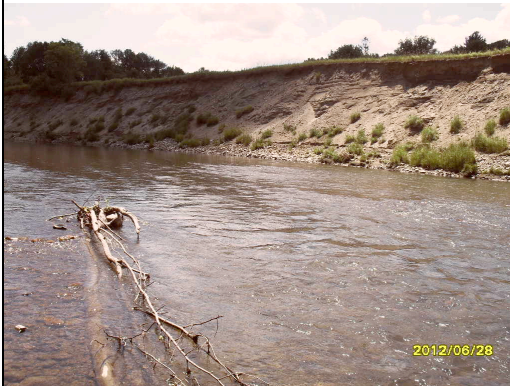
*Bank erosion*

Natural Resource and Assets	Problems	Priority Actions
<ul style="list-style-type: none"> <li>Access to Linear Park in beginning of stretch</li> <li>Some trails along river by Cole Field</li> <li>Wildlife</li> </ul>	<ul style="list-style-type: none"> <li>Bank erosion</li> <li>Incremental rip-rapping</li> </ul>	<ul style="list-style-type: none"> <li>Red-brown seepage from soil upstream of Cole Ave on left bank</li> <li>Pipe with slight sewer gas odor downstream of Cole Ave on right bank (See Priority Action for Immediate Attention section for both)</li> <li>Consider trimming trees</li> </ul>
