HOOSIC RIVER WATERSHED ASSOCIATION

# Shoreline Survey Report & Action Plan: Summer 2012

Report Compiled by Julieanne Fontana

# I. Introduction: Hoosic River Shoreline Surveys

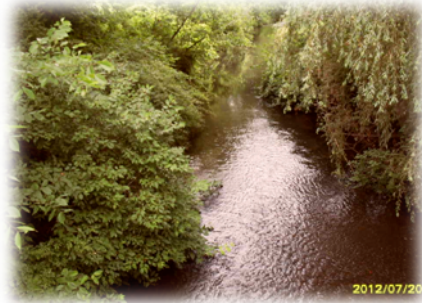
**Overview:** The first few miles of the south branch of the Hoosic originating at Cheshire Reservoir consists of a narrow, shallow waterway surrounded by marshland on alternating sides. This area, commonly referred to as the “jungle,” is not easily navigable by canoe, but can be viewed from the Ashuwillticook Rail Trail, which runs alongside the river into Adams. The cloudy water was less than 1 foot deep on average with a streambed of mostly cobbles and gravel. In the first half, marshlands were the only visible land use on both banks. After a dam just off Harbor Road, the riparian area became more wooded and the river flowed below the Rail Trail in a ravine. Use of riprap was observed on Harbor Road extension just before the bridge. The dam, with a 10’ drop, seemed in poor condition due to broken concrete at its sides.

*Beginning of south branch, commonly referred to as the “jungle”*

Natural Resource and Assets	Problems	Priority Actions
<ul style="list-style-type: none"><li>Access to marshlands and wooded area along Rail Trail</li></ul>	<ul style="list-style-type: none"><li>Condition of dam downstream of Harbor Road.</li></ul>	<ul style="list-style-type: none"><li>Contact DEP or DCR to inspect dam.</li></ul>

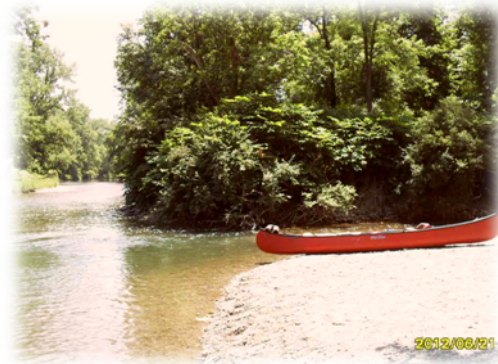
*Green River confluence*

**Overview:** This section of river begins after the three small dams in North Adams and is characterized by fast, cloudy water following a meandering path with a streambed of mostly cobbles and gravel. Heavy knotweed invasion was noted on both banks within the riparian area of trees, shrubs, grasses, and flowers. Land use visible from the river includes residential areas, roads, and undeveloped land. In the beginning of the stretch, animal tracks and slide marks potentially from an otter were observed. Also, concrete slabs were on the bank of the river about 100 yards downstream of the Ashton Ave. launch. The section ends when the Green River meets the Hoosic, next to Linear Park and upstream of Cole Field.

Natural Resource and Assets	Problems	Priority Actions
<ul style="list-style-type: none"> <li>Canoe access to section of river running through North Adams and Williamstown</li> <li>Walking trails from Linear Park, Williamstown</li> </ul>	<ul style="list-style-type: none"> <li>Some areas with trash and large dumped items, such as shopping carts</li> </ul>	<ul style="list-style-type: none"> <li>Potential cleanup spots with many shopping carts and large trash items such as a box spring</li> </ul>

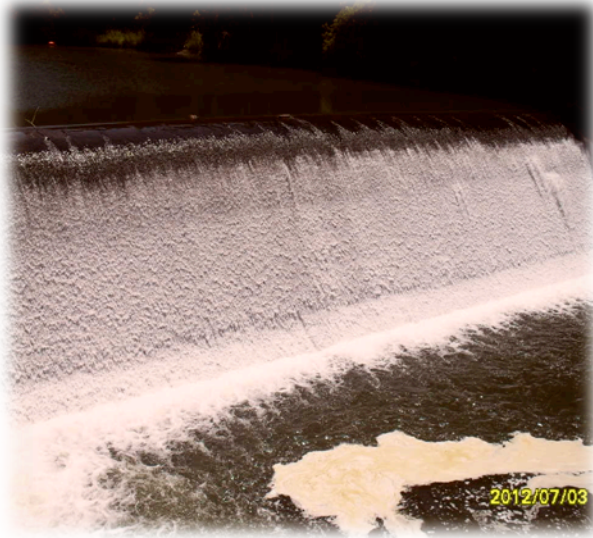
*Pownal Tannery Dam*

Erosion was present in some areas and run-off from roads, bridges, and fields entered the river. After the Tannery Dam, there was no longer knotweed invasion and the water had a slight greenish color. According to a local resident, the area downstream of the dam used to be a popular area for fishing trout, but no longer after a wastewater treatment plant spill. There was also one navigation hazard where concrete sections blocked the main flow of the stream.

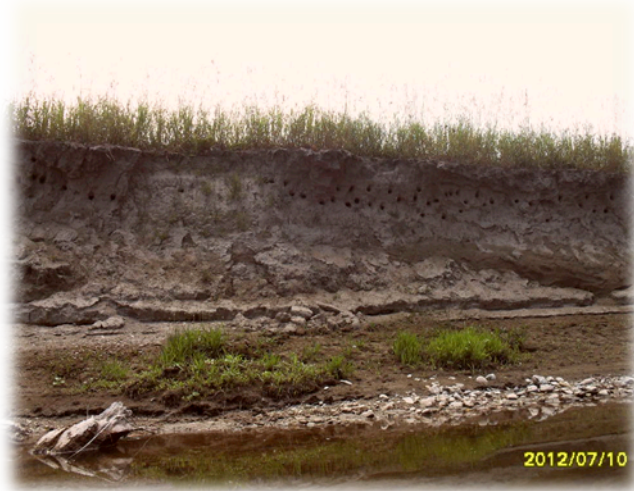
**Overview:** The streambed was made of cobbles and silt with generally less than 1-foot water depth in low water conditions. The meandering stream is characterized by bank erosion with bank wallow nests. There were two main areas where the nests were observed, one with swallows nearby and one deserted. The section also had brownish algae growing on rocks, and run-off from lawns, roads, bridges, and plowed fields. Towards the end of the section, there is a

beach with informal access for swimming, fishing, and potentially launching a canoe. The rest of the land along the river was used for agricultural purposes, roads, and a railroad on the right bank. Wildlife observed includes 4-inch fish, crayfish, a deer, and a muskrat. Birds include Great Blue Herons and smaller heron species, kingfishers, bank swallows, Common Yellowthroats, catbirds, Killdeer, sandpipers, a red tailed hawk, and a bald eagle.

Natural Resource and Assets	Problems	Priority Actions
<ul style="list-style-type: none"><li>Brown trout fishery</li></ul>	<ul style="list-style-type: none"><li>Leaking flood control gate at end of stretch</li><li>Concrete ripped and eroded on left bank next to Rt. 22</li><li>Navigational hazard of fallen trees</li></ul>	<ul style="list-style-type: none"><li>Excavator (See Priority Action for Immediate Attention section)</li><li>Beach with trash (common area for fishing brown trout)</li></ul>
