Hoosic River Watershed Association

2010 Watershed Report Card

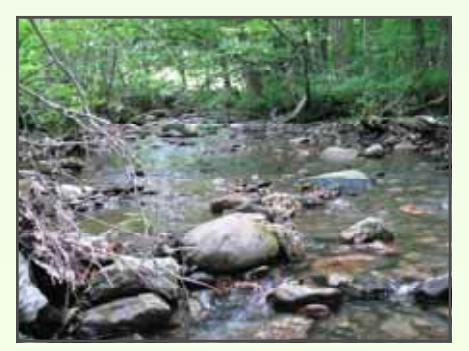
East Branch Green River (GE01)

Stream Name (Station/State) Water quality	2010 Stream Community Assessments
East Branch Green River (GE01/MA) Reference	Station GE01 is located approximately 200 m above Roys Road and is the 2010 reference station for the MA Hoosic River stations; the surrounding land use is predominately forested with some agriculture. Benthic community metrics had characteristics of non-impacted conditions: high number of sensitive, unique taxa, balanced community composition, and low number of tolerant taxa. The sample had slightly higher (28%) than expected (<20%) dominance by a single taxa. The habitat assessment indicated optimal conditions.
Hoosic River (HR07B/MA) Slightly impacted	Station HR07B is located above the Lime Street bridge in Adams, MA; and above the Adams Sewage Treatment Plant and Specialty Minerals. The surrounding land cover is residential, agriculture, and some forest. The habitat indicated suboptimal conditions, including reduced instream habitat, bank stability, bank vegetative cover, and riparian width, and increased sediment deposition. Benthic community metrics indicated slightly impacted condition, 75% similar to the reference. High numbers of tolerant taxa, moderately high percent dominance, and a less balanced community composition affected the score. In 1997 and 2002 the station was assessed as slightly impacted by MA DEP.

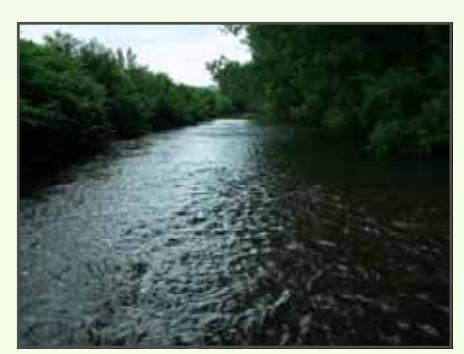
Hoosic River (HR07)

Hoosic River (HR07/MA) Slightly impacted	Station HR07 is located approximately 350 m downstream of the Adams Sewage Treatment Plant and Specialty Minerals in Adams, MA. The surrounding land cover is industrial, mining, waste disposal, agriculture, and low intensity residential. The habitat assessment indicated suboptimal conditions. Benthic community metrics indicated slightly impacted conditions, 75% similar to the reference. Low number of sensitive taxa, unbalanced community composition, and a greater number of tolerant taxa affected the score. This station had the lowest percent of dominance among the MA Hoosic River stations. MA DEP assessed this station in 1997 and 2002 and found it to be slightly impacted.
Hoosic River (HR2/MA) Slightly impacted	Station HR2 is located above the Hodges Cross Road (Route 8) bridge; the surrounding land cover is primarily developed residential, industrial, and agriculture. The habitat assessment indicated suboptimal/poor conditions, including reduced substrate habitat diversity, instream habitat, moderate sediment deposition, channel alteration, and reduced bank stability, bank vegetative cover and riparian width. Benthic community metrics indicated slightly impacted conditions, 60% similar to the reference; this station had the lowest similarity to the reference. Low number of sensitive taxa, unbalanced community composition, greater number of tolerant taxa, and moderately high percent dominance affected the score.
